Manhole Inspection Summary

Manhole # S25CC_001MH

Location Address: **1515 MYRTLE AVE**

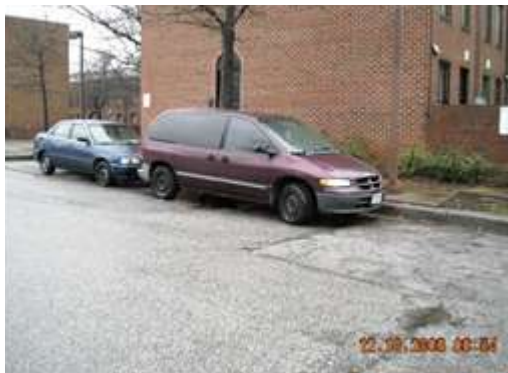
Location View

Comments **LOCATED MANHOLE AT 1515 MYRTLE AVE. THERE IS A VAN PARKED OVER MANHOLE, OCCUPANT OF ADDRESS DID NOT KNOW WHO OWNER WAS. ATTEMPTED ACCESS AT 10:05 AM, 12:05 PM, AND 3:00 PM. ON 12/09/08 - DUE DILIGIANCE**

VAN HASN'T BEEN MOVED LATELY
